Manhole Inspection Summary

Manhole # S49EE_036MH

Insp Date: **7/16/08 9:56 AM**

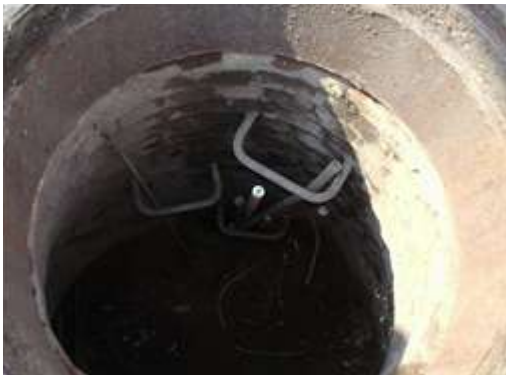
Defect 2

frame leaks

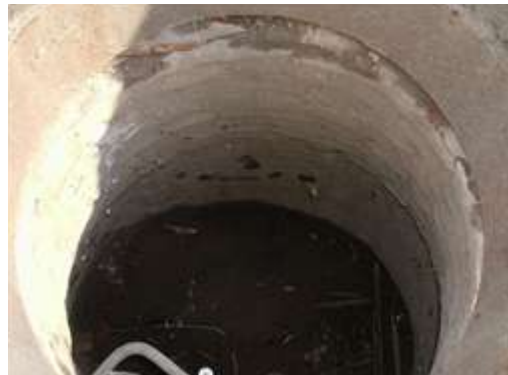
Defect 1

infiltration

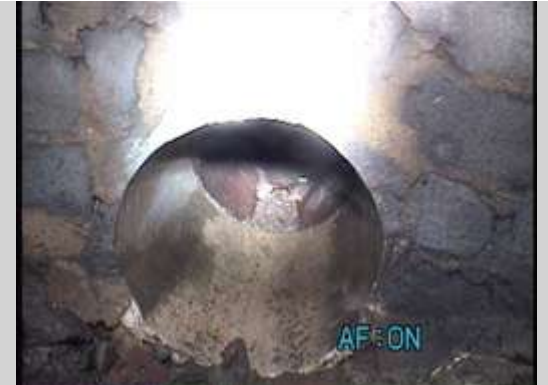
12 O'Clock Outflow

8 in. Circular Gravity Sewer
Pipe Out @ 12 O'Clock

Infiltration: **None** Pipe Seal Cond: **Sound**
